**Flood Control Project Maintenance  
Levee Inspections**  
**LMA District Cover Sheet**  
**Spring 2019 Levee Inspection Results**

**Reclamation District No. 2096 Wetherbee Lake**

**Levee Inspection Report By Mile - Spring 2019**

Waterway	Bank	Unit Miles	Inspection Start/End	Inspector
Unit No. 01 San Joaquin River	Right	0.16	05/01/2019 05/01/2019	Alberto De Leon

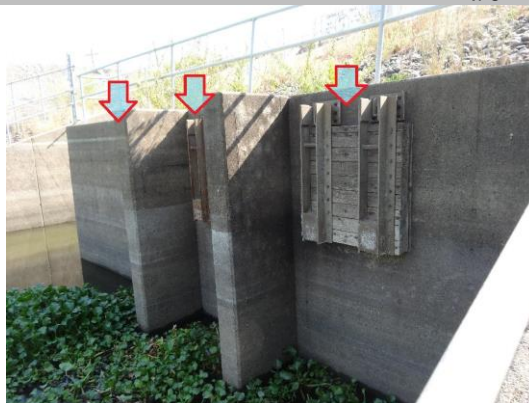
Photo 1 of 3 : UCIP\_SP\_2019\_21505\_36449.jpg

LM Start	0.02	Rating **	A/W	Issue No.	14
LM End	0.02	Issue Type +	Ma	Location *	
Category	Supplemental			GPS Latitude/Longitude	
				Start	End
Item	DWR UCIP LMA Responsibility			37.773852 °	37.773852 °
				-121.298413 °	-121.298413 °
DWR ID	22737

WS view: three wooden flap gates for drainage pipes. Concrete headwall at levee slope end.

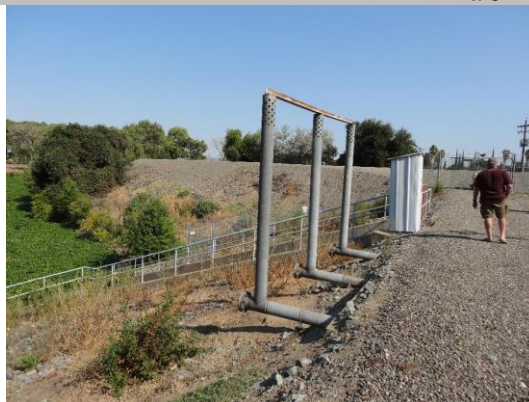
Photo 2 of 3 : UCIP\_SP\_2019\_21505\_36448.jpg

WS view: three air vents for three drainage pipes on levee shoulder.

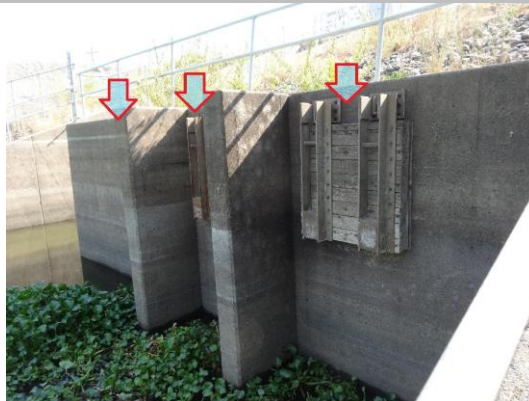
Photo 1 of 3 : UCIP\_SP\_2019\_21507\_36456.jpg

LM Start	0.02	Rating **	A/W	Issue No.	15
LM End	0.02	Issue Type +	Ma	Location *	
Category	Supplemental			GPS Latitude/Longitude	
				Start	End
Item	DWR UCIP LMA Responsibility			37.773835 °	37.773835 °
				-121.298419 °	-121.298419 °
DWR ID	22740

WS view: three wooden flap gates for drainage pipes. Concrete headwall at levee slope end.

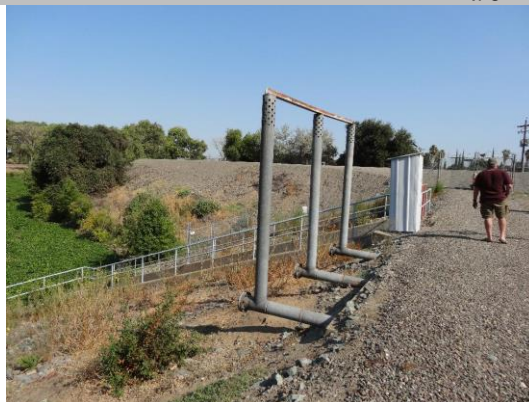
Photo 2 of 3 : UCIP\_SP\_2019\_21507\_36455.jpg

WS view: three air vents for three drainage pipes on levee shoulder.

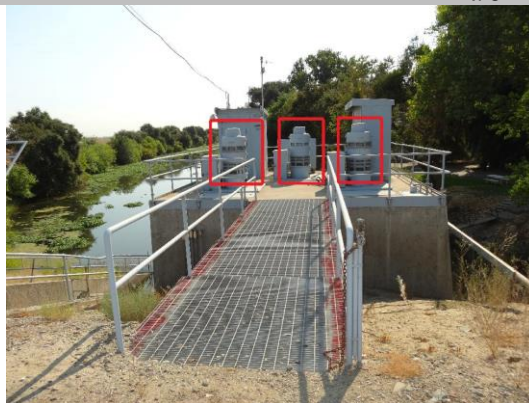
Photo 3 of 3 : UCIP\_SP\_2019\_21507\_36454.jpg

LS view: automatic pumping plant with three pumps. Steel walkway to pump platform.

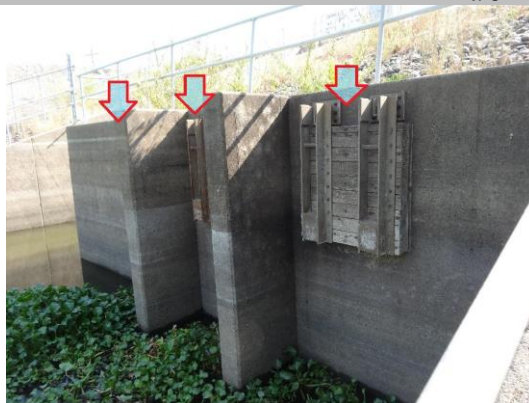
Photo 1 of 3 : UCIP\_SP\_2019\_21508\_36463.jpg

LM Start	0.03	Rating **	A/W	Issue No.	16	
LM End	0.03	Issue Type +	Ma	Location *		
Category	Supplemental			GPS Latitude/Longitude		
				Start		End
Item	DWR UCIP LMA Responsibility			37.773818 °	37.773818 °	
				-121.298423 °	-121.298423 °	
DWR ID	22739

WS view: three wooden flap gates for drainage pipes. Concrete headwall at levee slope end.

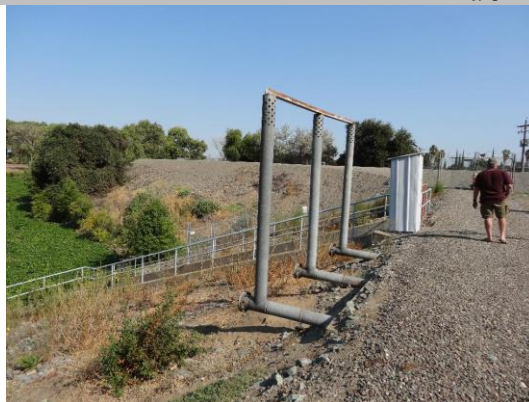
Photo 2 of 3 : UCIP\_SP\_2019\_21508\_36460.jpg

WS view: three air vents for three drainage pipes on levee shoulder.

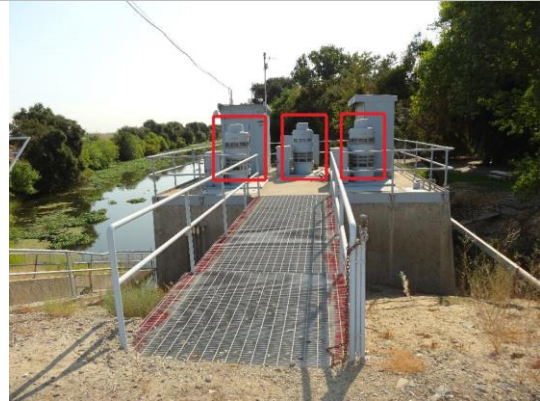
Photo 3 of 3 : UCIP\_SP\_2019\_21508\_36461.jpg

LS view: automatic pumping plant with three pumps. Steel walkway to pump platform.

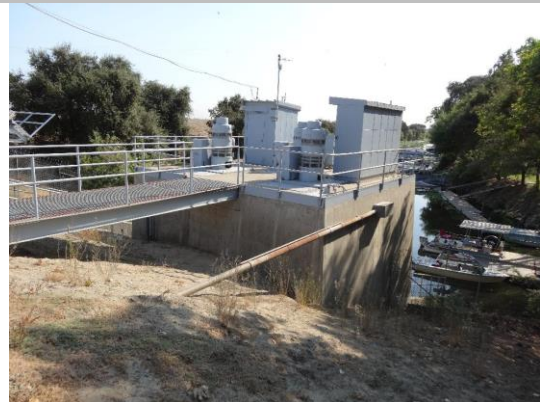
Photo 1 of 2 : UCIP\_SP\_2019\_21506\_36453.jpg

LM Start	0.03	Rating **	M	Issue No.	17
LM End	0.03	Issue Type +	En	Location *	
Category	Supplemental			GPS Latitude/Longitude	
				Start	End
Item	DWR UCIP Field Study			37.773800 °	37.773800 °
				-121.298428 °	-121.298428 °
DWR ID	24666				
Comment Code					
Inspector Comment					
FS_ID:21506					
DS_ID:24666					
EP_NO: N/A					
Repair Type: Non-Urgent					
Crossing Status: Found					
UCIP Comments: - more information needs to be find from LMA/DWR					
Inspector for this crossing. - needs to find whether this pipe passes through the levee.					
FIELD_STRUCT_DESC: 4-inch steel pipe of an unknown purpose through the levee and to the pump platform, 3 feet below the crown. It is an element of the pumping plant. Field study discovered utility crossing.					
FS Date: 9/10/2013

LS view: 4-inch steel pipe (right) through the levee and to pump platform.

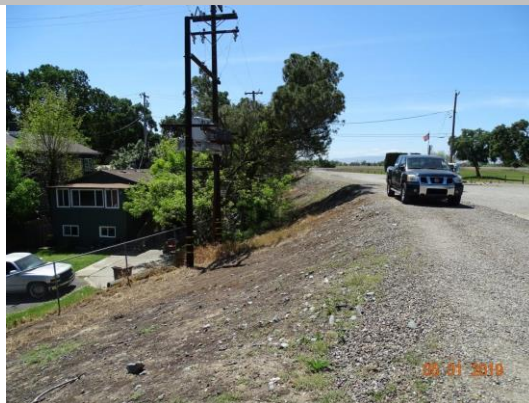
Photo 1 of 1 : SP\_2019\_RD2096\_117\_10\_20190514\_00019.jpg

LM Start	0.06	Rating **	A	Issue No.	10
LM End	0.16	Issue Type +	Ma	Location *	LS
Category	Earthen Levee			GPS Latitude/Longitude	
				Start	End
Item	Vegetation			37.773375 °	37.771824 °
				-121.298721 °	-121.298403 °
DWR ID	DWR_RD2096_01_s_2019_10				
Comment Code					
V1 : Control annual grass and weeds on the levee slopes and easements.					
Inspector Comment					
Annual vegetation is well maintained.

Typical view of vegetation on landside slope. (Spring 2019)

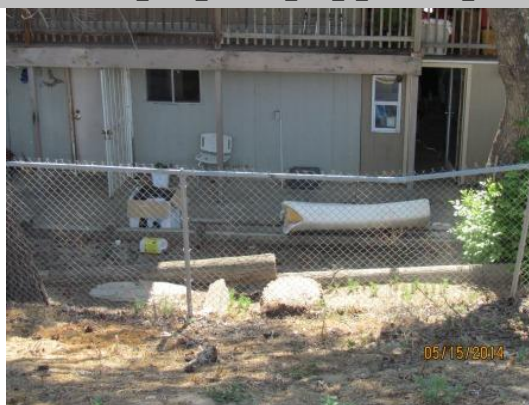
Photo 1 of 1 : SP\_2019\_RD2096\_117\_9\_20190313\_00002.jpg

LM Start	0.06	Rating **	N	Issue No.	9
LM End	0.06	Issue Type +	Ma	Location *	LS
Category	Earthen Levee			GPS Latitude/Longitude	
				Start	End
Item	Trim / Thin Trees			37.773348 °	37.773348 °
				-121.298475 °	-121.298475 °
DWR ID	DWR_RD2096_01_s_2014_9				
Comment Code					
T5 : Tree stumps.					
Inspector Comment					
There is a pine tree stump at the levee toe.

View of the tree stump at the landside levee toe.

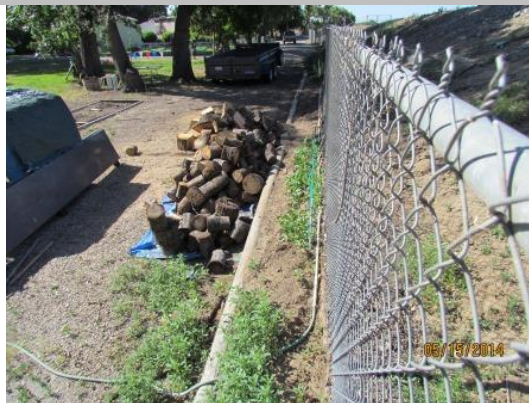
Photo 1 of 1 : SP\_2019\_RD2096\_117\_13\_20190313\_00006.jpg

LM Start	0.08	Rating **	M	Issue No.	13
LM End	0.08	Issue Type +	En	Location *	LS
Category	Earthen Levee			GPS Latitude/Longitude	
				Start	End
Item	Encroachments			37.773021 °	37.773021 °
				-121.298430 °	-121.298430 °
DWR ID	DWR_RD2096_01_s_2014_13				
Comment Code					
RW : Retaining Wall					
Inspector Comment					
There is an approximate 1 foot by 50 feet retaining wall at the levee toe with irrigation and landscaping.

View of the retaining wall at the landside levee toe.

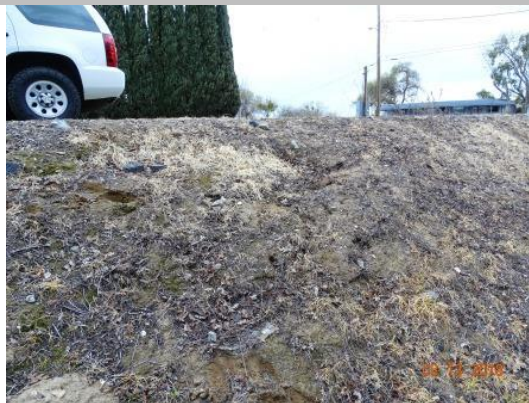
Photo 1 of 1 : SP\_2019\_RD2096\_117\_6\_20190313\_00001.jpg

LM Start	0.09	Rating **	A/W	Issue No.	6
LM End	0.09	Issue Type +	Ma	Location *	LS
Category	Earthen Levee			GPS Latitude/Longitude	
				Start	End
Item	Animal Control			37.772891 °	37.772891 °
				-121.298454 °	-121.298454 °
DWR ID	DWR_RD2096_01_s_2016_6				
Comment Code					
A3 : No rodents visible, but rodent burrows visible; need to backfill and compact or grout burrows.					
Inspector Comment					
The LMA has an effective rodent control program. Monitor this location for possible future activity.

View of the previously rodent infested area on the landside levee slope.

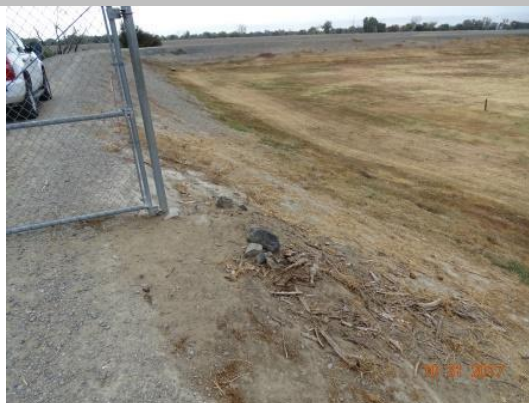
Photo 1 of 3 : SP\_2019\_RD2096\_117\_11\_20190313\_00003.jpg

LM Start	0.12	Rating **	M	Issue No.	11
LM End	0.12	Issue Type +	Ma	Location *	WS
Category	Earthen Levee			GPS Latitude/Longitude	
				Start	End
Item	Slope Stability			37.772434 °	37.772434 °
				-121.298433 °	-121.298433 °
DWR ID	DWR_RD2096_01_s_2015_11				
Comment Code					
S3 : Repair the levee slope damaged by vehicle traffic and prevent access where possible.					
Inspector Comment					
The LMA restricted access but still a regrade and re-compaction of the damaged waterside levee slope is required.

View of the material placed to prevent vehicles from driving around the gate.

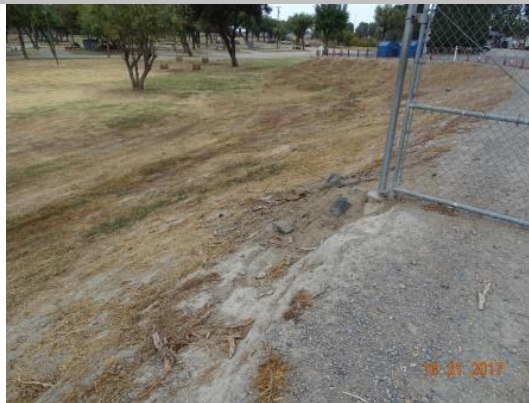
Photo 2 of 3 : SP\_2019\_RD2096\_117\_11\_20190313\_00004.jpg

Another view of the material placed to prevent vehicles from driving around the gate. Looking downstream.

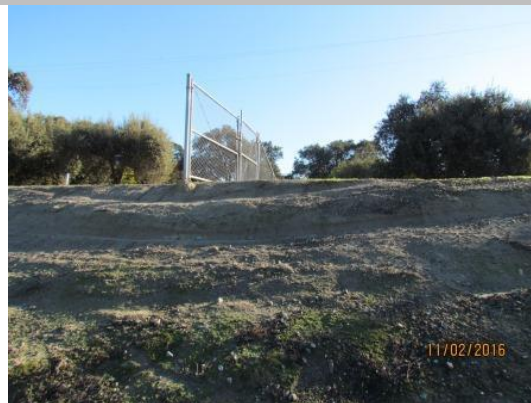
Photo 3 of 3 : SP\_2019\_RD2096\_117\_11\_20190313\_00005.jpg

LM Start	0.12	Rating **	M	Issue No.	11 (cont)	
LM End	0.12	Issue Type +	Ma	Location *	WS	
Category	Earthen Levee			GPS Latitude/Longitude		
				Start		End
Item	Slope Stability			37.772434 °		37.772434 °
				-121.298433 °		-121.298433 °
DWR ID	DWR_RD2096_01_s_2015_11					
Comment Code						
S3 : Repair the levee slope damaged by vehicle traffic and prevent access where possible.						
Inspector Comment						
The LMA restricted access but still a regrade and re-compaction of the damaged waterside levee slope is required.

View of the waterside slope damaged by vehicles.
